**ORDINARY
MAINTENANCE
MANUAL
MAGNI M24 (M24C)
GYROPLANE**

Issue A-DECEMBER 2012

APPROVED MAINTENANCE MANUAL FOR THE MAGNI M24 (M24C)

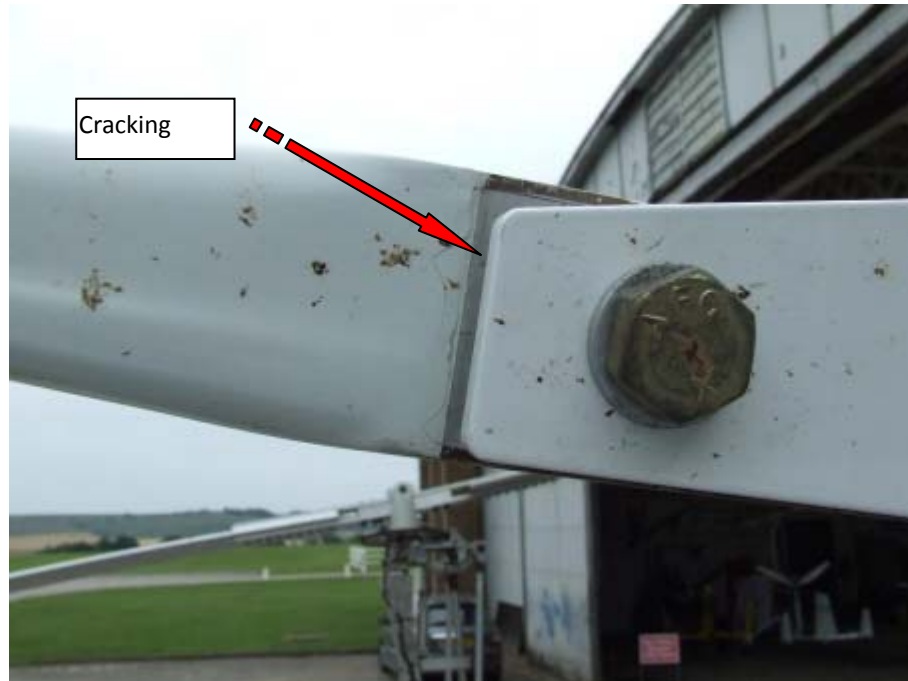
After a period of time some cracking at the root of the rotor blades may become apparent. An example of this cracking is shown in the photographs below:

The cracks shown in these pictures are due to the flexing of the paint/filler used in the manufacture of the rotor blades. They are not evidence of the onset of structural failure of the main blades.
